Finding fault

O&M case studies: Two hypothetical scenarios and one actual case study of solar faults in the field serve as a reminder of both the importance of sophisticated O&M, and the need for a professional and proactive approach to PV maintenance.

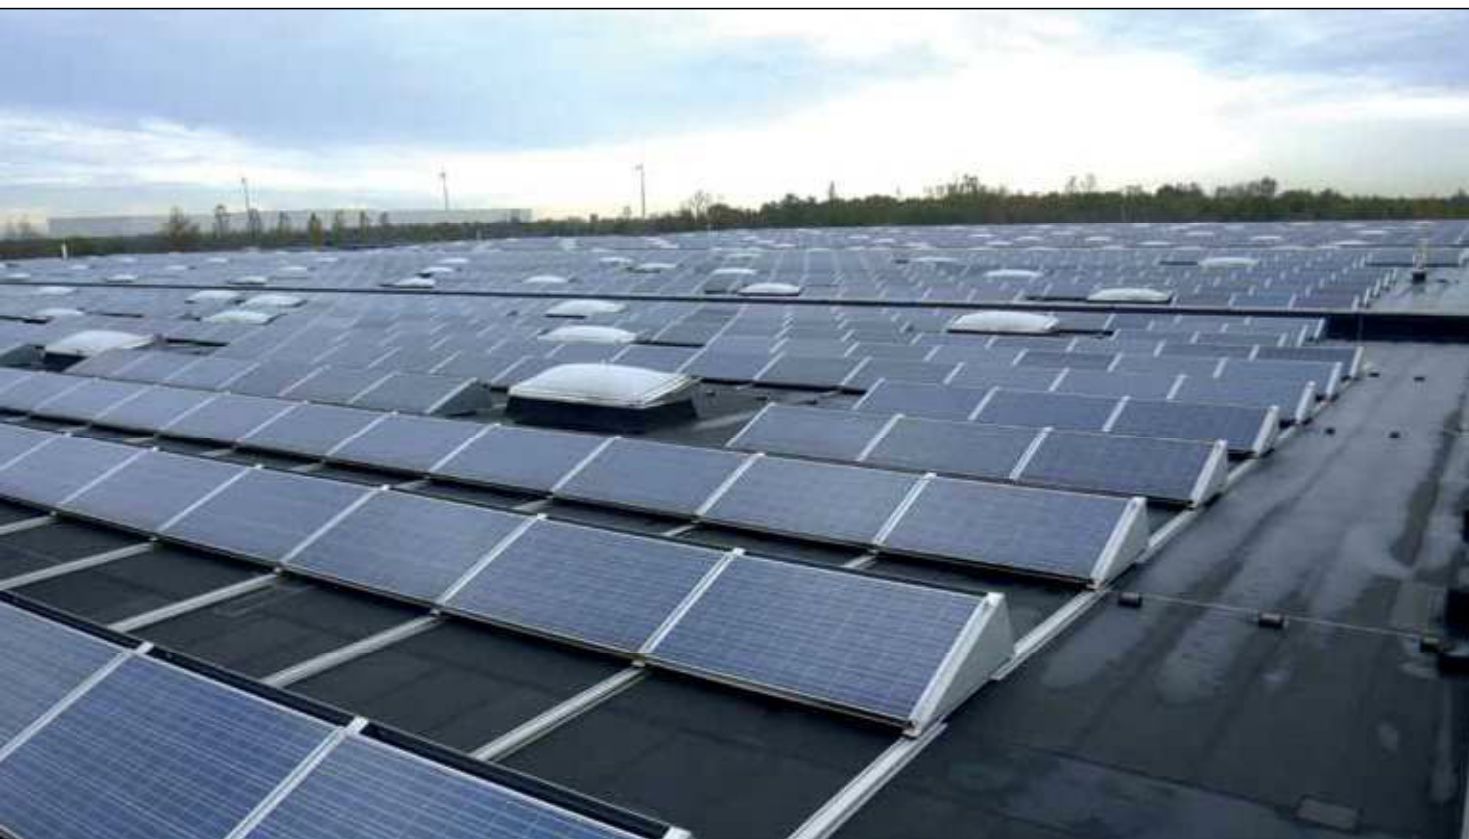
A rooftop array in Germany. If several module strings fail completely, the result is usually high yield loss. At that point, it is worth finding out exactly where the faults are, and how to correct them.

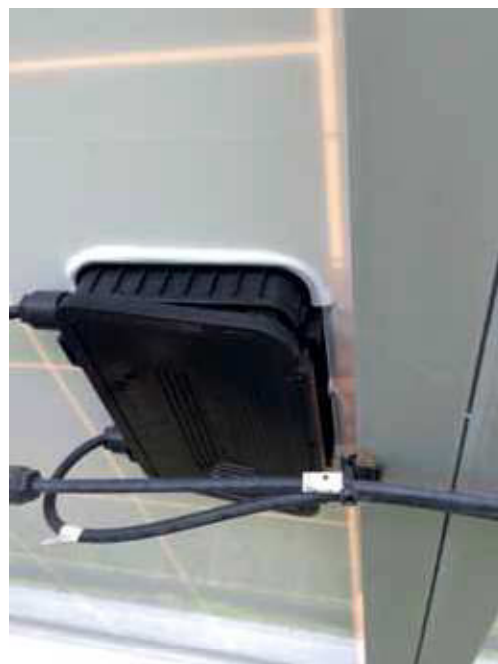
Bypass diodes fail regularly, either because they do not have a high enough power rating or because they are overloaded due to nearby lightning strikes. This hypothetical case is realistic and shows how O&M service provider Enovos would respond.

Bypass diodes in the junction box can be a regular source of module failure.,

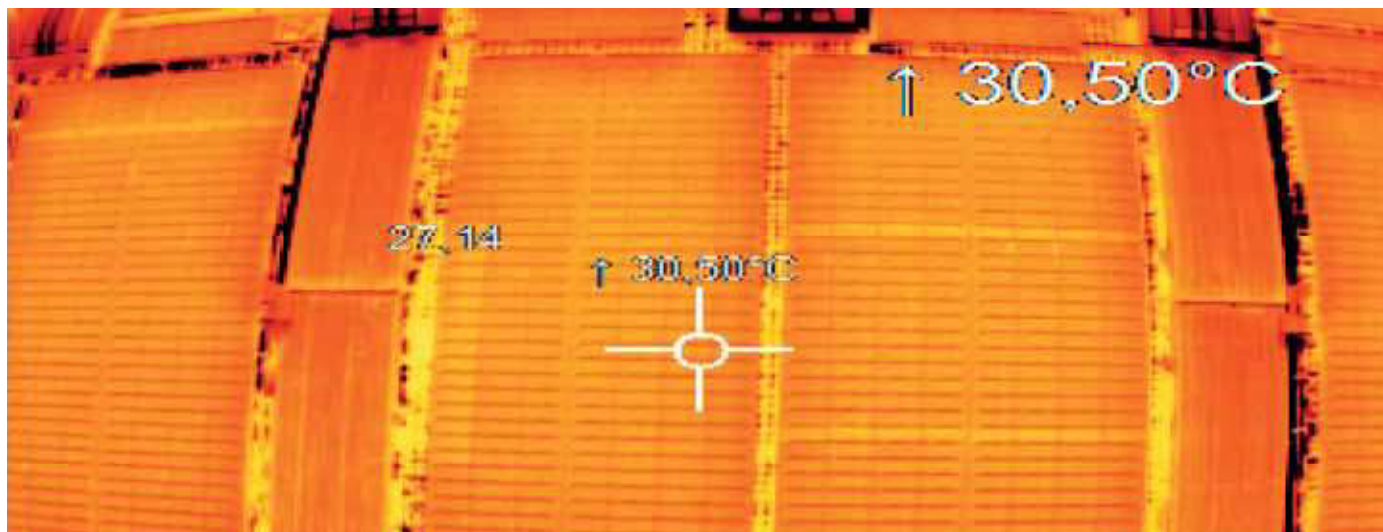
therefore recommends that the operator carry out a drone-based thermographic survey of the entire plant for around €2,000. An external service provider takes the images and sends them to the plant manager. The result confirms the manager's suspicion. The thermographic image shows that 20 module sub-strings have failed either completely or partially, and identifies the individual modules affected. It is likely that the problem has existed for several years.

A thermographic examination of a solar plant can pinpoint faults already identified, and spot additional areas of weakness or underperformance.

Results of the investigation: The plant manager transfers the results of the thermographic examination onto a diagram of the modules and sends a technician to the plant. Based on the module diagram, the technician can repair the individual

modules and strings in a targeted manner. He discovers a large number of module connectors are disconnected. These were probably not reconnected following a major rebuild of the plant in 2012.

The technician found no defective plugs in the system. He reconnected the disconnected plugs. The repairs increased the yield of the plant by almost 1%. With the 2009 feed-in tariff averaging €0.37 per kilowatt hour, the plant generated an additional €3,700 per year after repair.
